# TECHNICAL INFORMATION

## Finished products / Chassis concerned : TX807

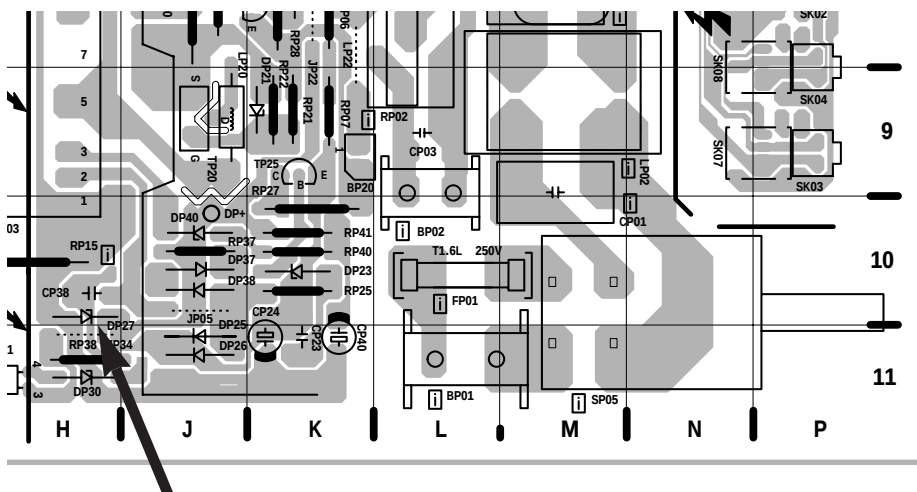
Failure of the 24-volt zener diode in position DP27 for no specific reason.

Check and if necessary change the zener diode from a BZX55C24 to a 27-volt device type number BZX55C27 parts code is **60447870**.

Comment : As a preventive measure it is recommend that this diode be replaced when the television is repaired for whatever reason.

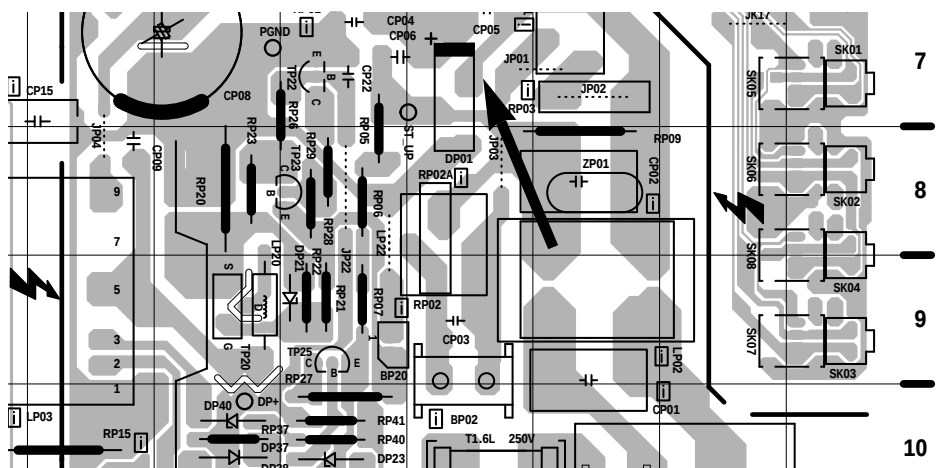
Failure of bridge rectifier RS205-K106 (600 V) at circuit reference number DP01.

Mains borne voltage spikes exceeding 600-volts

Change the bridge rectifier for a device type with a much higher breakdown voltage of type number FBI2M4S1 (1 KV) parts code is **25371810**.

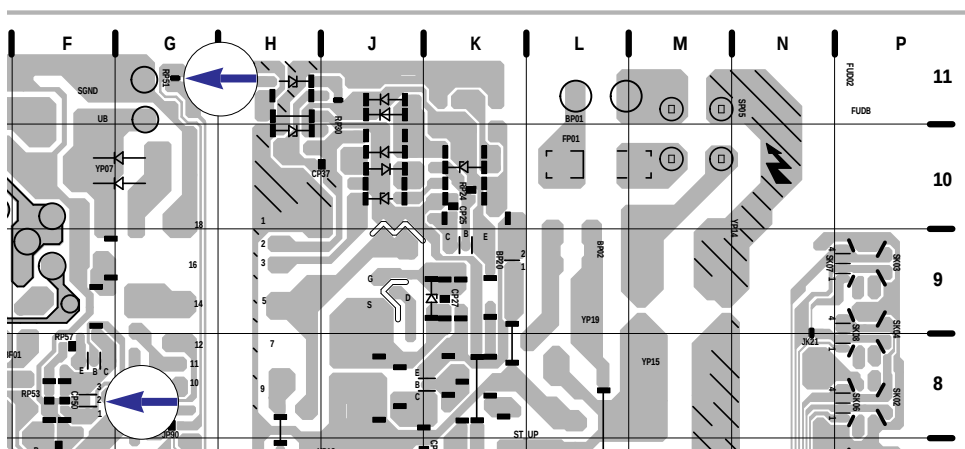
The picture being modulated by the low frequency audio components at high volume levels.

Poor regulation of the power supplies.

- Add a 4.7k $\Omega$  5% 0.10W resistor in position RP51 parts code is **60079900**.
- Change the value of capacitor CP50 from a 470pF to 220pF 10% 50V parts code is **10311200**.

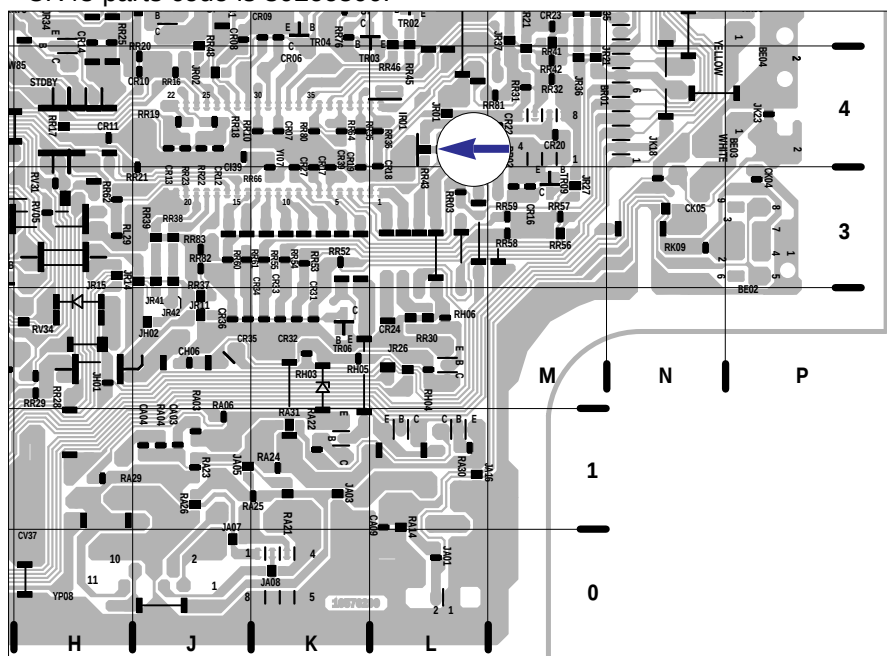
Crackling noise in stand-by (Burst mode)

- Change the value of resistor RR43 from 47kΩ to 470kΩ 5% 0.100w part code is **40077500**.
- Connect a 10nF 20% 16v capacitor between the base of transistor TP52 and ground in position CR43 parts code is **30166500**.

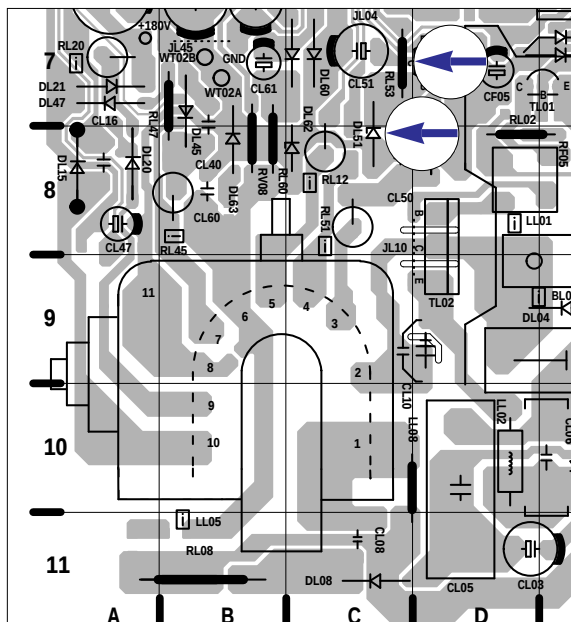
**Subject : Improving the stability and reliability of +5VR supply voltage to the Tuner/Teletext Module.**

To improve the stability of the base drive current of transistor TL50 please change the following :

- the zener diode at circuit location DL51 from a 1N5233B 6V to a BZX55B 5V6  
parts code is **70438200**.
- the value of resistor RL53 from 820Ω to 390Ω 5% 0.250W parts code is **15007960**.
