This documentation is only intended for qualified technicians who are aware of the respective safety regulations. Subject to modifications. © Copyright Whirlpool Corp. Service Consulting Center Europe

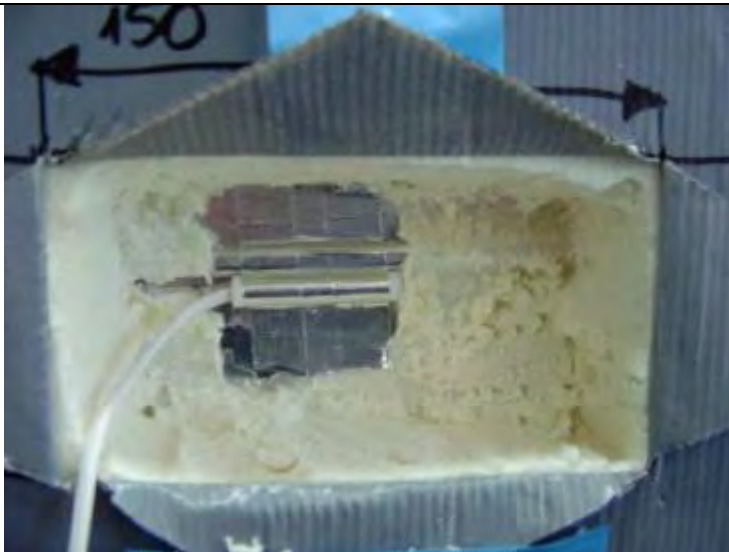
**Step6:** Fix the new NTC by using the aluminium adhesive tape.

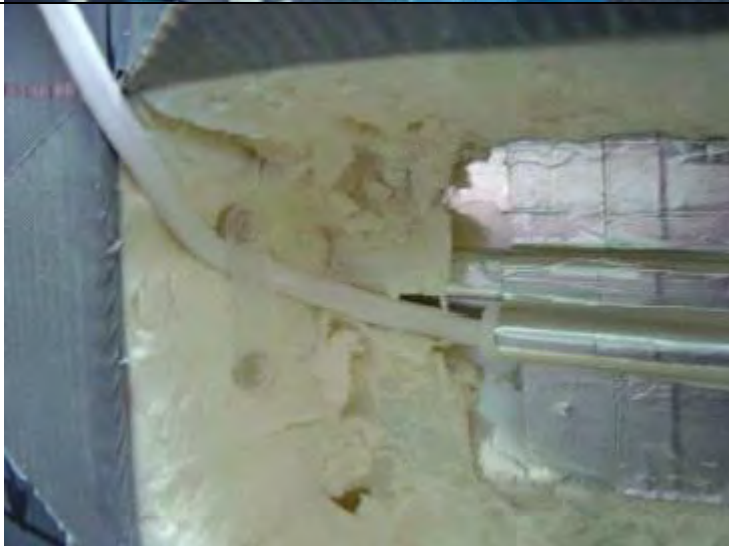
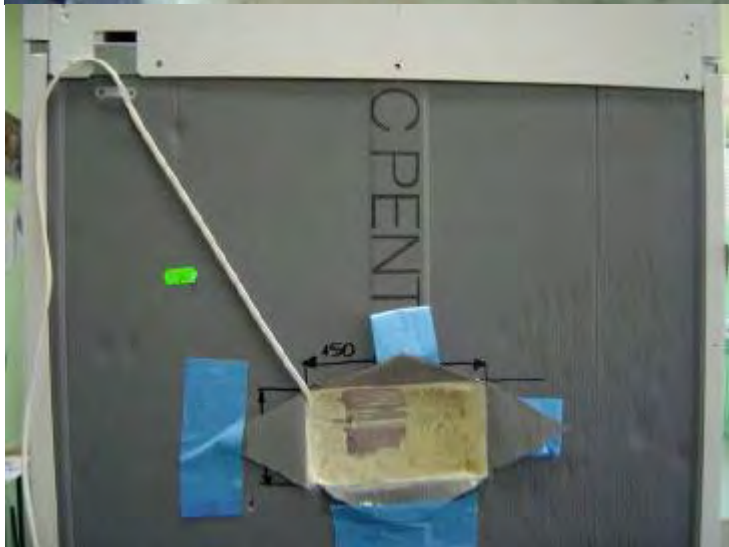
**Step7:** Fix the NTC wire by using the wire relief.

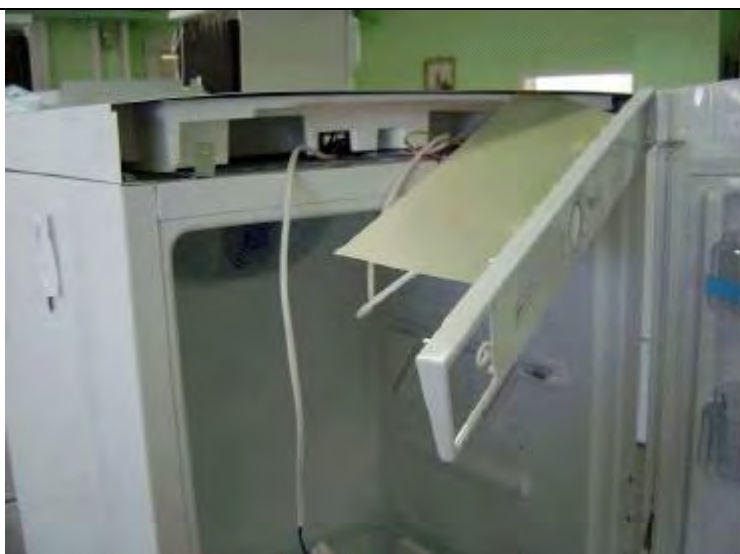
**Step8:** Remove the front panel and install the sensor wire under the top cover. Cut the old sensor wire and assembly the front panel.

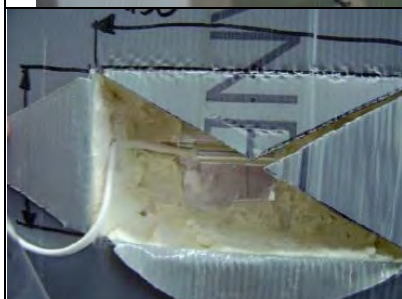
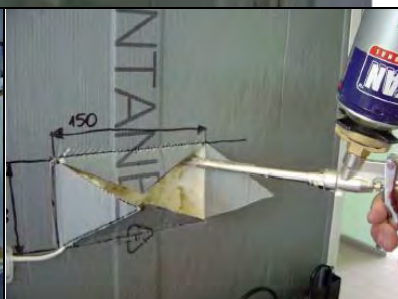
**Step9:** Close the "window" by using the foam and take care, that the wire of the sensor is placed in the bottom corner.

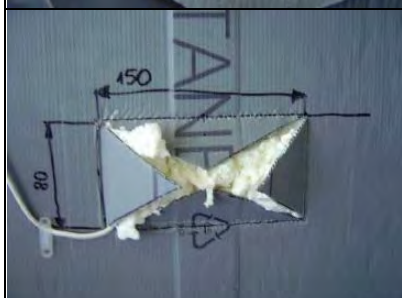
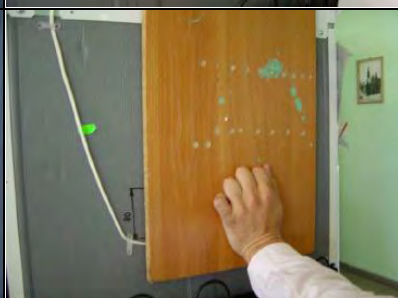
**Step10:** Close the poliwave and keep the surface flat.

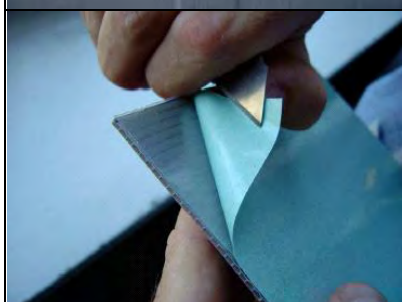
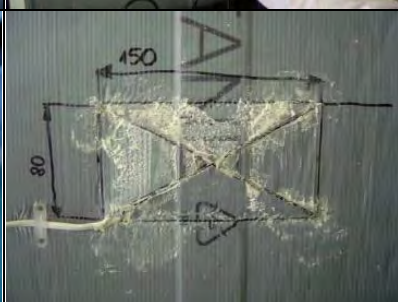
**Step11:** Unstick the tape and remove the surplus of foam from this area.

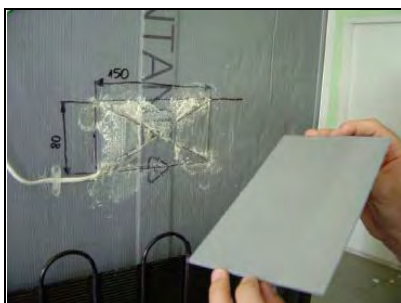
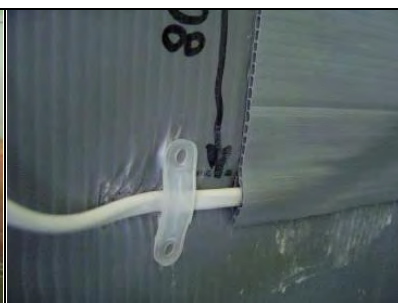
**Step12:** Stick properly the poliwave on the cutted part.

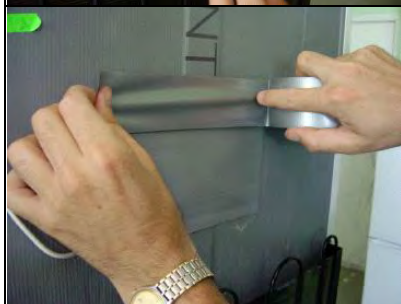
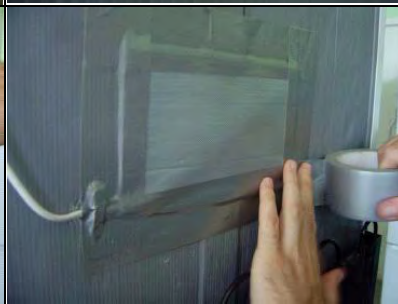
**Step13:** Place the adhesive tape around the poliwave in order for a better sealing.

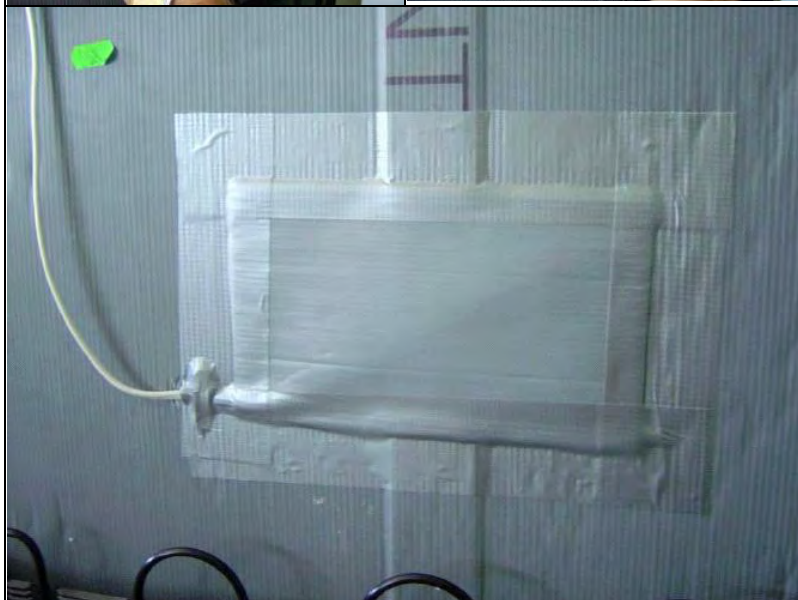
**Step14:** Make a final visible check for a proper grip of the tapes without air bulbs.
